Problems of TBMs in Water Bearing Ground

Lars Babendererde ¹

Abstract

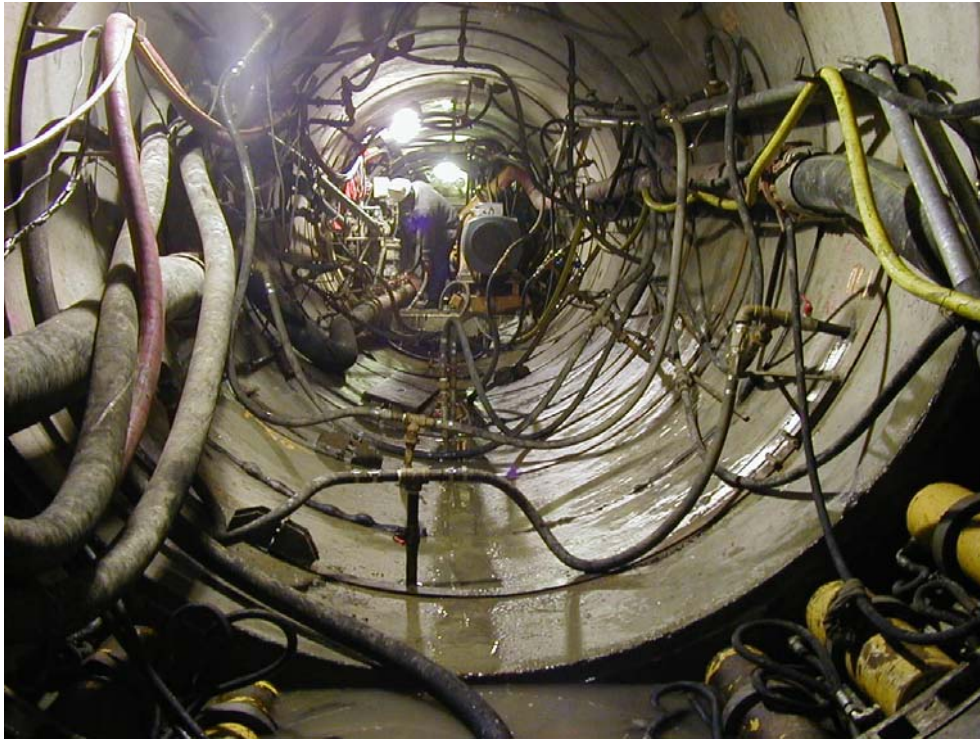
Figure 3: Injection outlet pattern

Finally a special Bentonite suspension, containing polyanyonic cellulose, foaming agent and water soluble cutting oil was viscous and stable enough to keep the steering gap open. This suspension was injected in a controlled sequence under high pressure through a narrow pattern of outlets in the string.

In addition to the creation of -stable lubrication, the pore water pressure in the soil around the string was increased by the high injection pressure, thus reducing the shear strength in the sand to the stage of liquefaction.

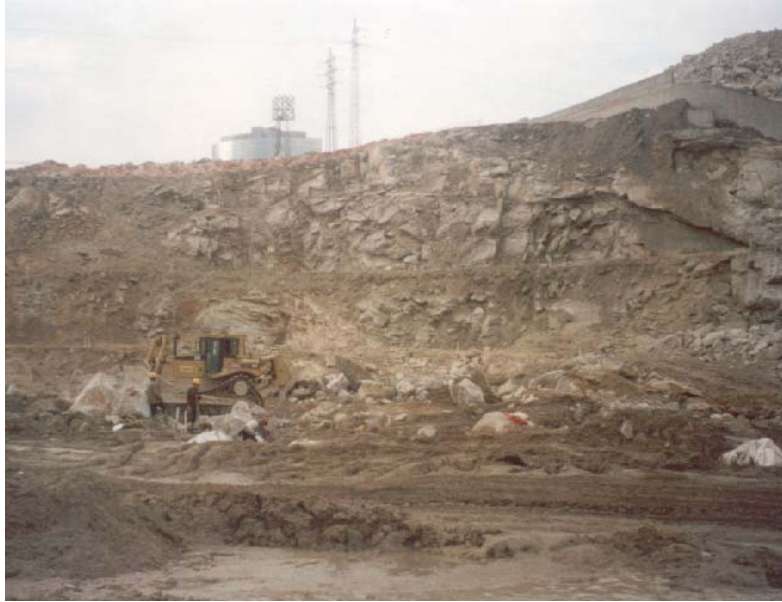
Figure 6: Heterogene geology

The rock mass through which the tunnels have to be excavated comprises of Granite. The conditions vary from fresh to moderately weathered high strength granitic rock to completely weathered soil-like materials. It has to be realized that granite “core stones” of variable size are embedded in soil-like weathered material and that this results in mixed face conditions for the tunnel drive.

The permeability of the granitic mass is very heterogeneous and varies between $k = 10^{-4}$ to 10^{-6} m/s.

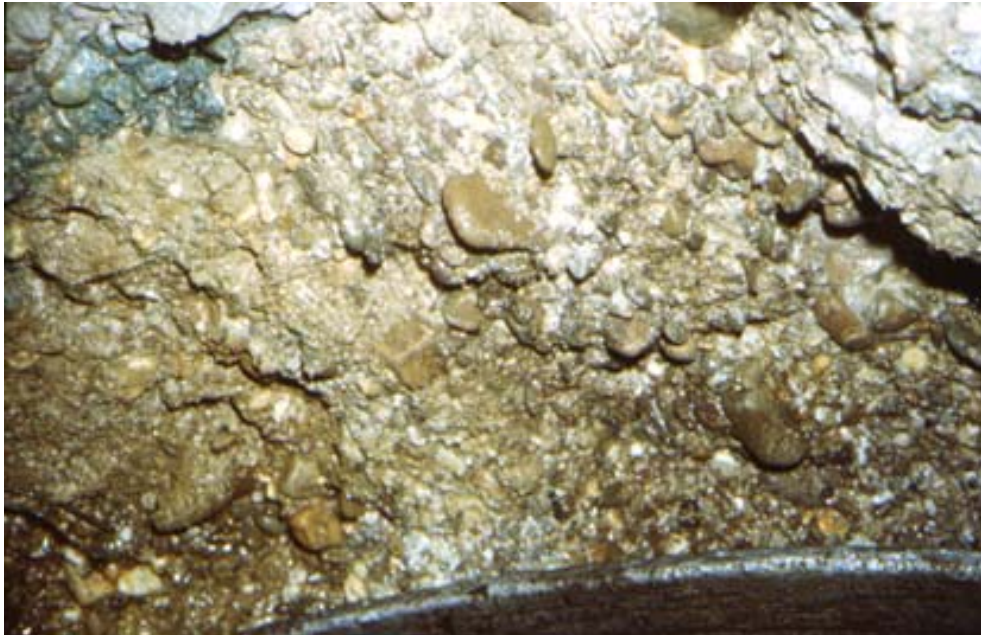
Figure 11: Glacial formed geology

A tunnel drive in a glacial formed geology, as in Berlin, has to face stones and boulders embedded in a soft soil –matrix. These ground conditions represents a challenging task for pressurized TBM drives.

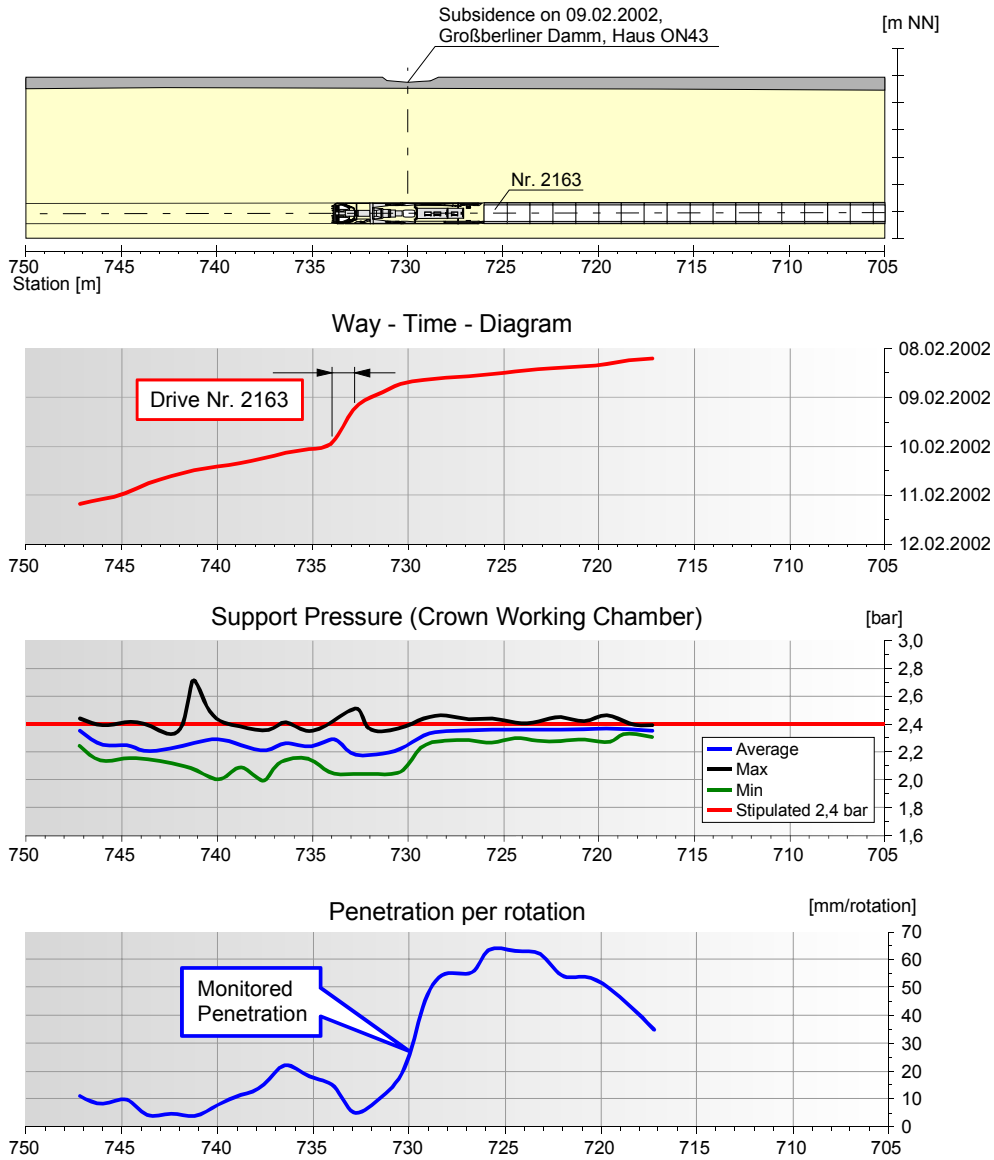
Figure 12: Data monitoring of TBM operation

An analysis of the machine and operation data shows that the TBM had been driven with a relatively high penetration rate of 45-60 mm per rotation. Encountered stones had been ripped off the face and crushed by the stone crusher. In this section where the cutter head was obviously blocked the number of stones had increased. The now larger number of stones banked up at the invert of the working chamber and blocked the cutter head.

Analysis of the objective data has demonstrated that the TBM had been operated in that section of the alignment with too high a rate of advance which had caused the event.

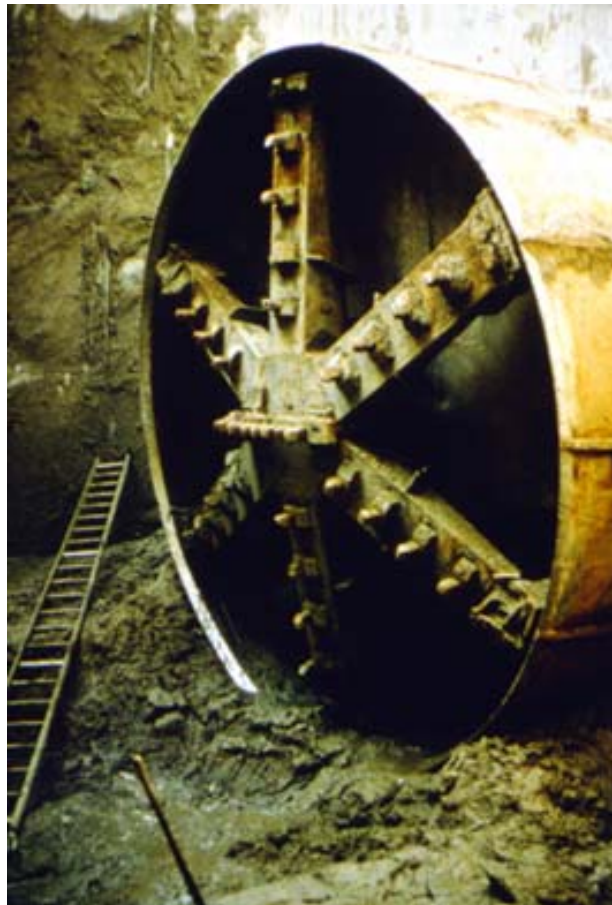
Figure 13: Prototype Slurry TBM 1974

At the beginning of the tunnel drive with Slurry-TBMs, the cutter heads had been equipped with simple steel bars as excavation tools. Smaller stones were ripped-off the face whereas boulders or blocks were shattered at the face by hand-operated hydraulic splitters from the working chamber under compressed air.

Stones and pieces of boulders which could not pass through the transport pipe lines because of their size were taken out of the empty working chamber by hand. Experienced crews did this during the period in which the segments were installed under the cover of the tail shield.

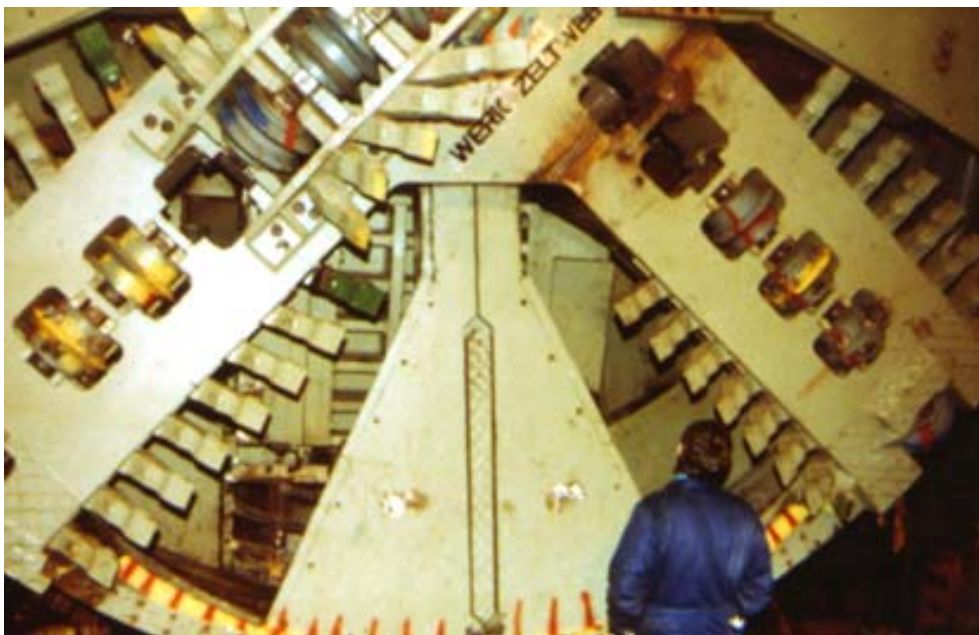
Figure 14: Tool combination – discs and scrapers

In 1986 the cutter heads were fitted for the first time with disc cutters to grind down stones and boulders in glacial geology with a pressurized TBM. Today, cutter heads are fitted with a combination of disc cutters and scraper bits. The disc cutters are spaced up to 100 mm apart, and running 25-30 mm ahead of a series of scraper bits. The disc cutters should grind down the hard stones and boulders whereas the scraper bits should shave-off the weak materials such as sand/gravel, silt or clay.

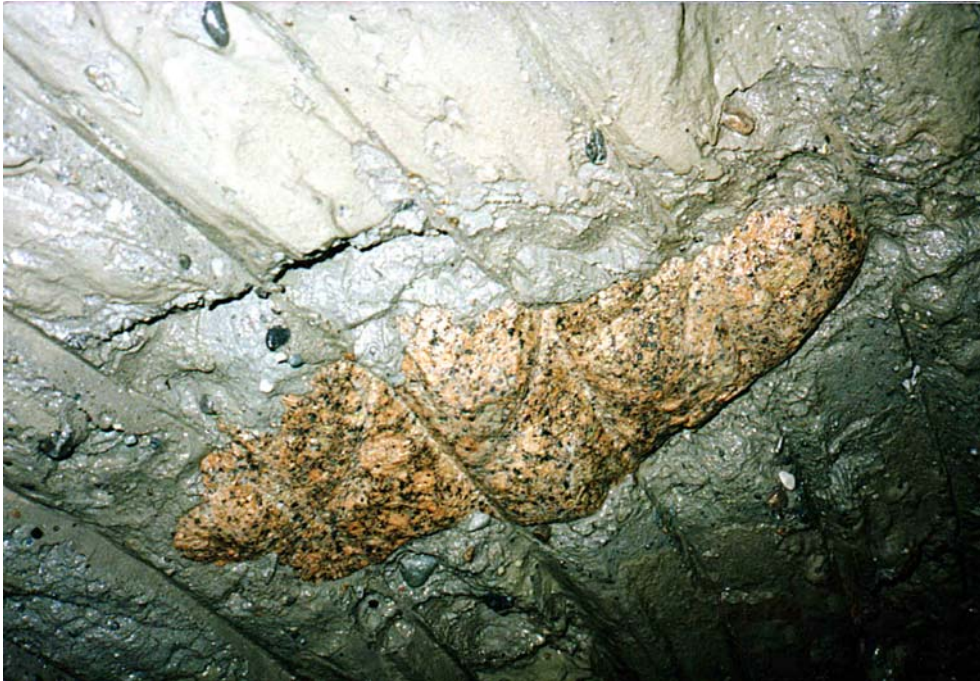
Figure 16: Boulder ground down

Grinding down these obstacles at the face does not endanger the stability of the face and is effective independent of the size of stones or boulders. The rubble of disintegrated boulders can easily be pumped through transportation pipe lines. An additional stone crusher is not required for this procedure on larger TBMs with a sufficient diameter of transportation pipe line. However the rate of advance is limited by the restricted penetration rate.

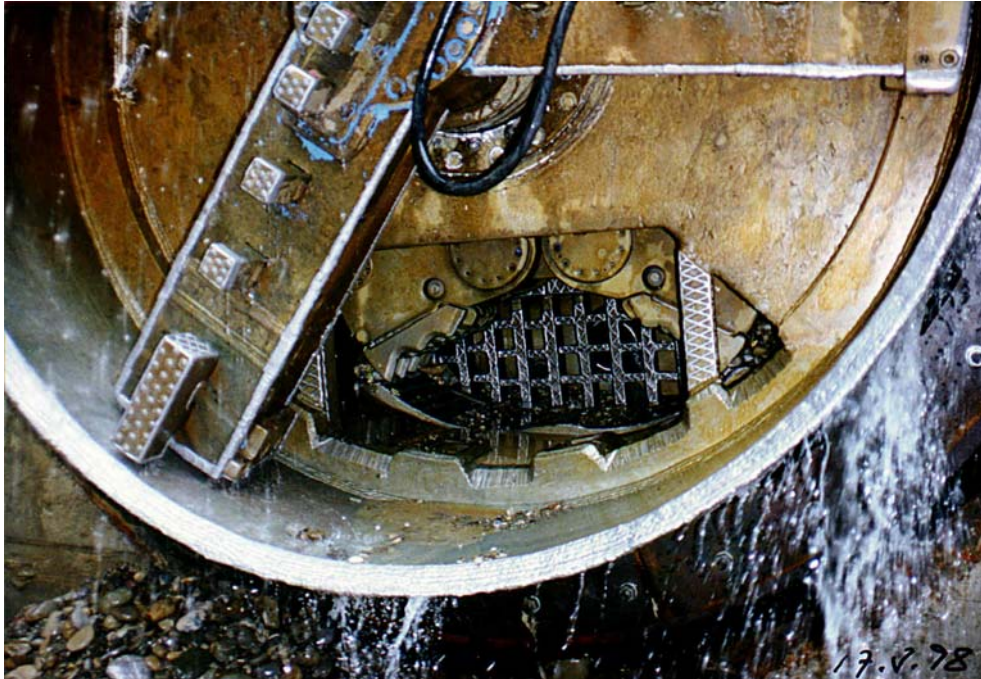
Figure 17: Inlet of transportation pipe line with grill and crusher

Stones and boulders not ground down at the face fall down to the bottom of the working chamber and must be pushed through a stone crusher to the inlet of the transportation pipe line. The undefined forces for this transportation are generated by the inflow of excavated material and the suction effect of the circulation pump of the transportation pipe line.

However if the distance between the back the -cutter head and the pipe line inlet is too great, the ripped-off stones will be banked up and finally- block the cutter head. This effect is adversely influenced by increasing numbers of stones.

It is a frequently formulated opinion that a stone crusher installed in front of the inlet of the pipe line can solve the transportation problems of ripped off stones or boulders. There are stone crushers installed in some TBMs which may crush boulders with a diameter of 80 cm. But in ripping such boulders off the face, the cutter head will suffer enormous damage and the face will at least locally collapse. Additionally, the flow of excavated material is frequently interrupted during the closure sequence of the crusher. Also fine-meshed grill creates a hindrance to an unimpeded flow of loaded slurry and consequently a risk to a blockage of the cutter head.

The dimension of a stone crusher should be limited to a size which can crush boulders smaller than 30 cm. Larger boulders must be ground down at the face to that diameter.
